1.0 EXECUTIVE SUMMARY AND INTRODUCTION

The purpose of this Heritage Impact Assessment is to record the heritage assets at 1655 Dupont Street, Toronto, as identified in the Reasons for Designation 2005, and to review adjacent properties and to assess the impact of the proposed development illustrated by Atkins + Van Groll on those assets and to indicate methods of mitigating any negative impacts.

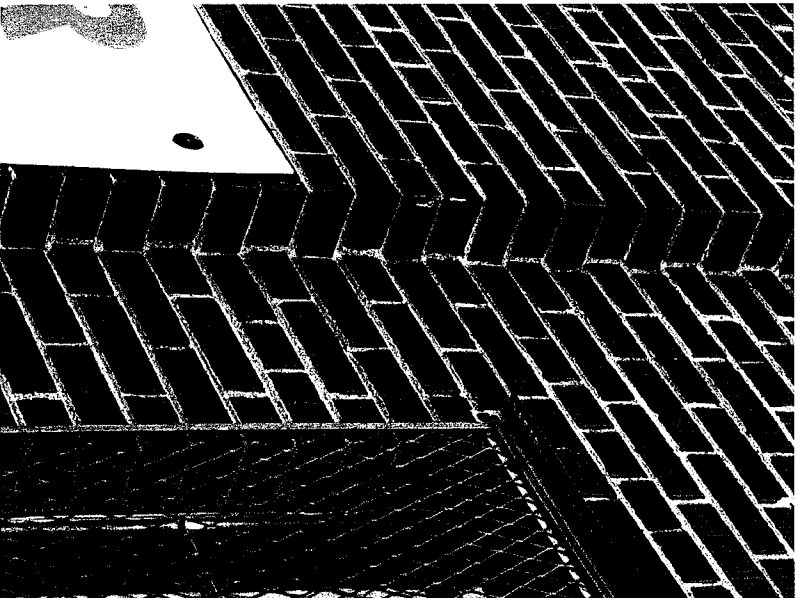
From a visual survey and from the discussion with the structural engineers working on the alterations to the property, the existing building is in sound condition with a number of overdue maintenance problems. The brick masonry of the exterior walls has developed a patina of age from a century of atmospheric deposits, but otherwise is not significantly deteriorated by spalling or cracking of bricks, or by erosion of the mortar joints.

The north façade consists of the earlier portion on the west and the later portion on the east. The west portion has a parapet capped by glazed terra cotta capping tiles. The east portion has a parapet capped by metal flashing. Some of this metal parapet flashing has deteriorated and the brick parapets may have been damaged from excessive moisture saturation and freeze-thaw cycles.

Figure 14 - Condition of masonry and windows

The existing steel sash windows are typical of the Critall Hope single glazed industrial sashes that were used for most of a century on industrial and some commercial buildings. The windows have a number of cracked lites and some locations have been modified to accept window A/C units and ventilation grilles. The operating casement and hopper/awning sashes are still in operating condition. The steel muntin bars of the windows have corroded in some locations and have shed the protective film of paint in many locations.
